Manhole Inspection Summary

Manhole # S01UU1004MH

Insp Date: **8/1/06 9:03 AM**

Location Address: **3814 GLEN AVE**

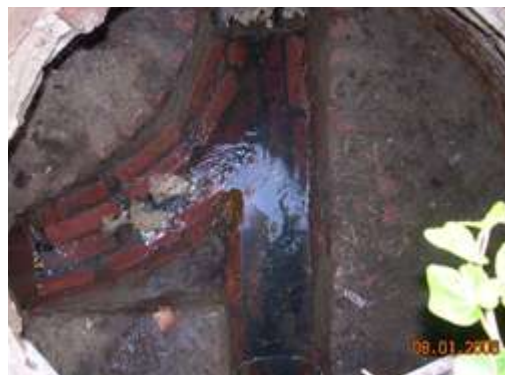
Top View

Bench ☒ Exists Material: **Brick** ☐ Parged ☒ **Debris** (not Condition related)

Channel Material: **Brick** ☐ Parged ☒ **Debris** (not Condition related)

Surcharge ☒ **Evidence Of Surcharge** Depth: **1** (ft.) ☐ Active Surcharge Present

Evidence of surcharge - Bench debris.
Channel debris.

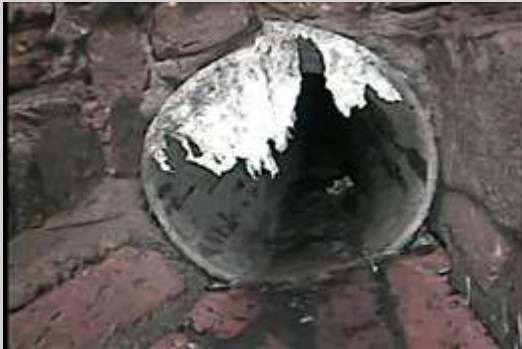
8 in. Circular Gravity Sewer Pipe Out @ 12 O'Clock

pipe lined

Infiltration: **Evidence** Pipe Seal Cond: **Unknown**

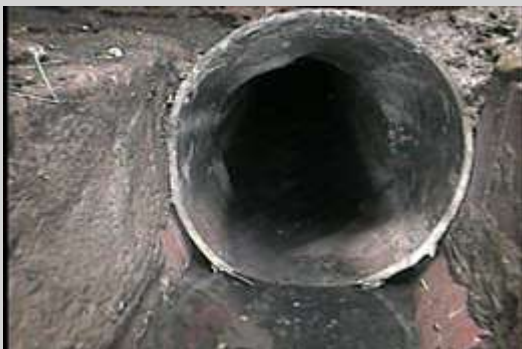
8 in. Circular Gravity Sewer Pipe In @ 6 O'Clock

pipe lined

Infiltration: **Evidence** Pipe Seal Cond: **Roots**

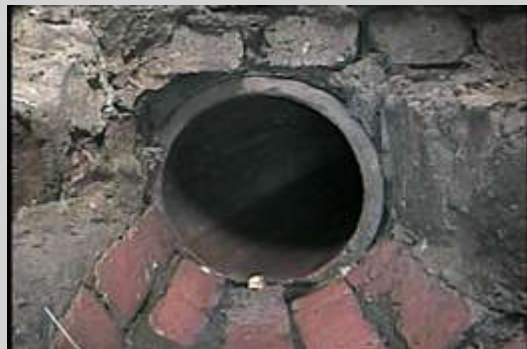
Pipe In @ 9 O'Clock

Infiltration: **None**

Pipe Seal Cond: **Sound**
